**Executive Summary:**

**Site/Project Location:** Johnson's Corner Terminal

**Date of Inspection:** 22 November 2016

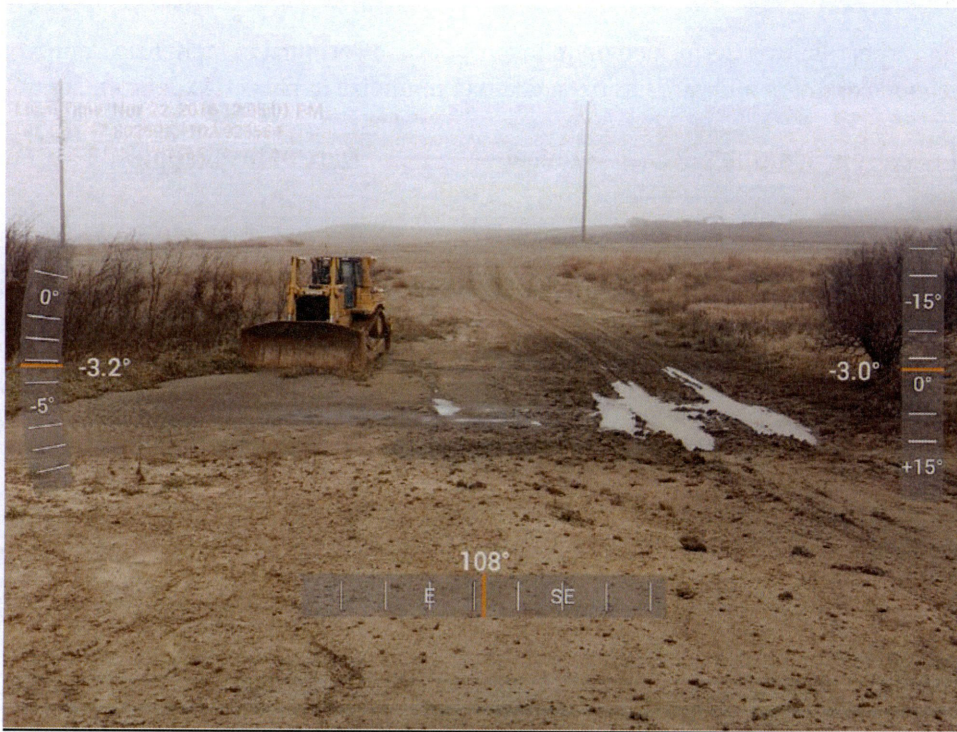
Vegetation removal and topsoil stripping was complete. Keitu noted on January 29, 2016 likelihood of tree and shrub removal based on discussions site staff. On this date, it appeared construction of the two access roads occurred. Chokecherry (*Prunus virginiana*) was identified as the likely dominant species cleared.

**Report Photo #1 Access Cleared through Trees/Shrubs**

As Built Inspection to confirm shrub mitigation actions consistent with order, not submitted plan.

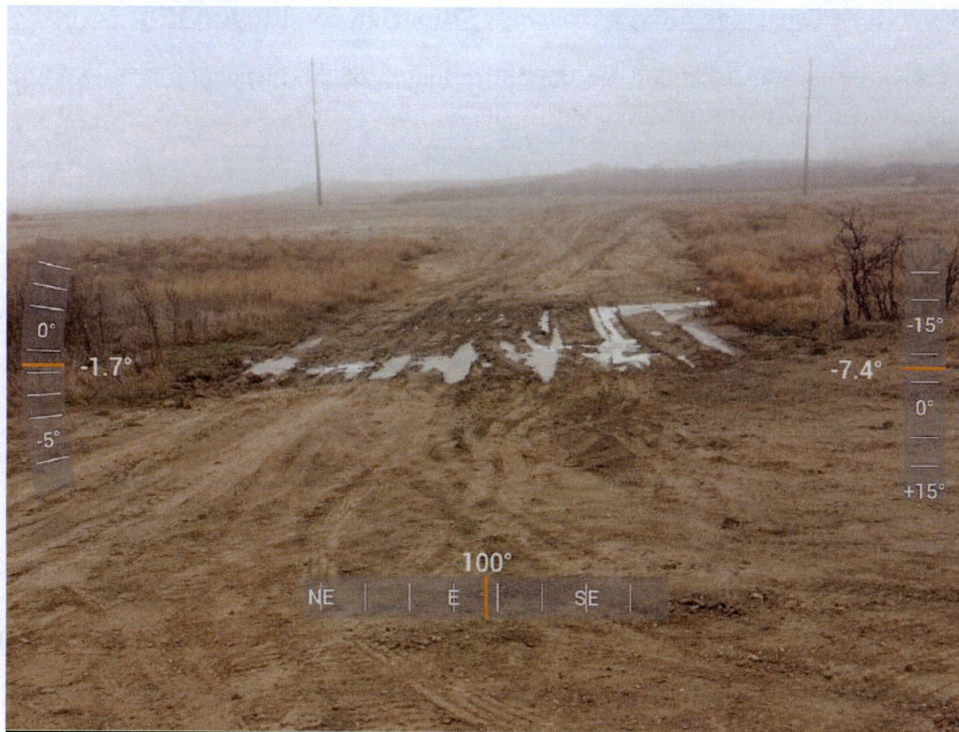
**Report Photo #2 Second Access Cleared through Shrubs**

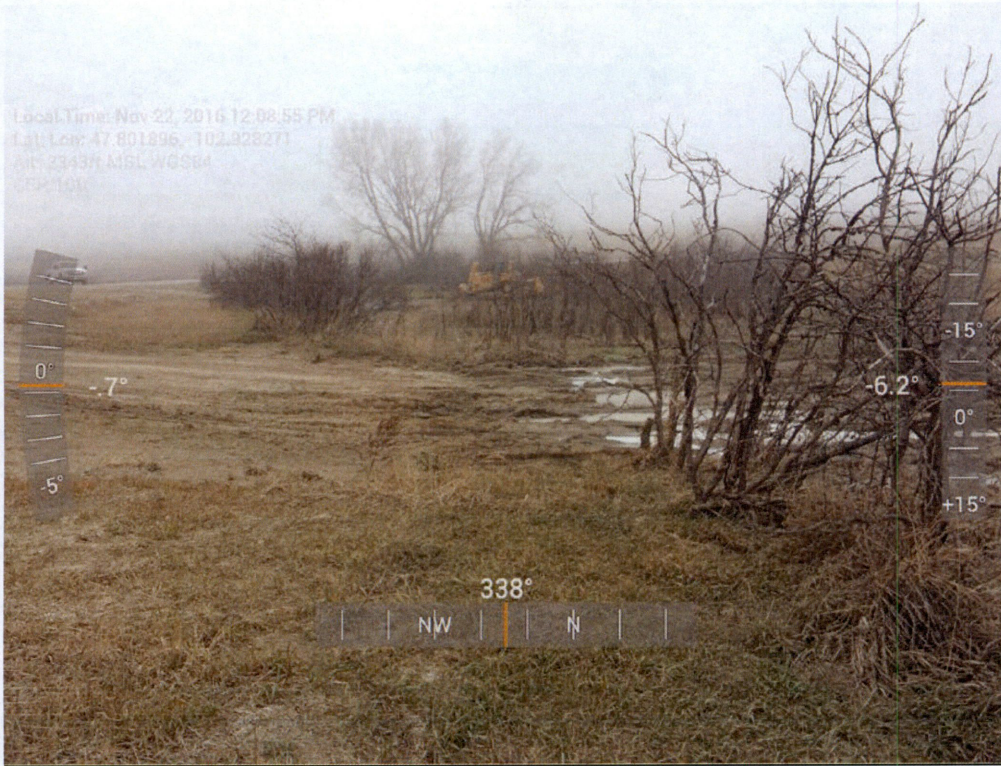
**Report Photo #3 View of the Two Accesses**

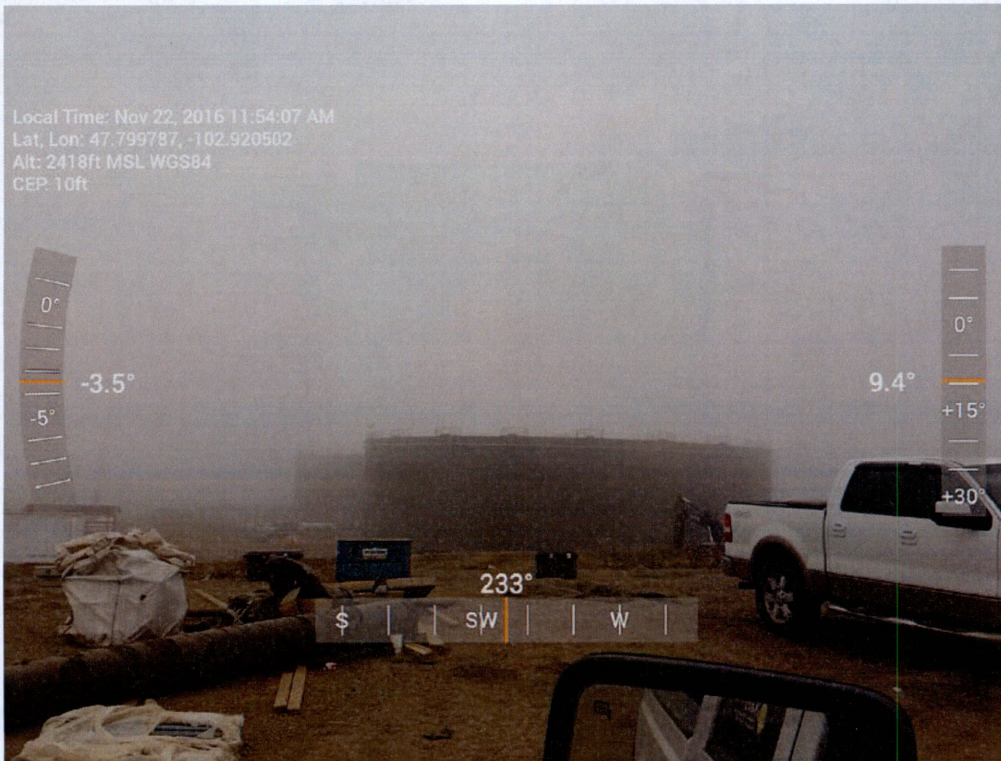
Tank and ancillary facility construction at site continues. Care was taken around terminal boundaries.

**Report Photo #4 Tanks under Construction**

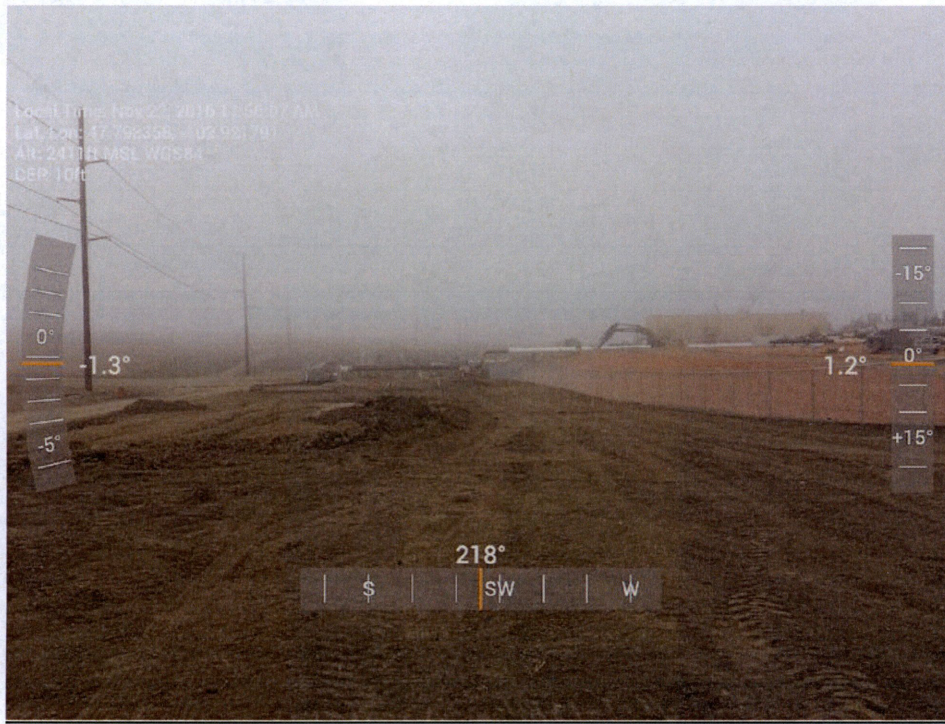
**Report Photo #5 Construction Crews Working Onsite**
